Geophysical Investigation of Road Failure Using Electromagnetic Profiles along Opoji, Uwenlenbo and Illeh in Ekpoma -Nigeria

I. Aigbedion

Department of Physics/Geophysics, Ambrose Alii University, Ekpoma-Nigeria

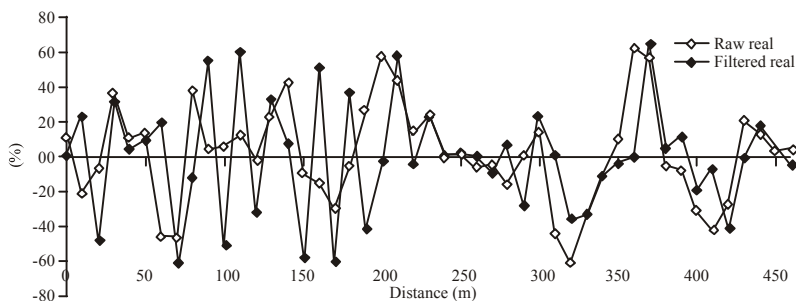
Profile 1: Opoji road , Ekpoma

From profile 1ie Opoji Road, Ekpoma. It is obvious that intervals 0-70m is fairly stable. While intervals 80-110m is unstable that is weak and conductive. Between 200-250m the zone is observed to be incompetent (unstable), while intervals 260-460m is observed to be fairly stable (Table 1).

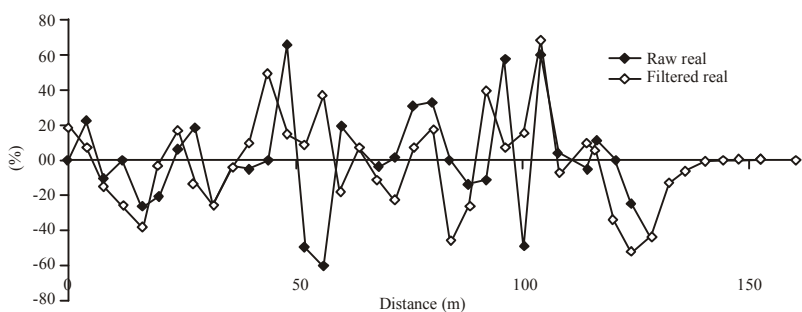
Profile 2: Uwenlebo Road, Ekpoma

From profile 2 Uwenlebo Road, Ekpoma, it is observed that interval 0-36 m is stable and none-conductive. While between 40-116 m we have fairly stable zone, then between 120-136 m we have a stable or none-conductive zone. Between 140-160 m is a fairly stable zone, while, 164-200 m is neither weak nor competent, or there was no reasonable signal i.e. the earth subsurface material are near homogenous as seen in Table 1.2 and the profile 2 graph.

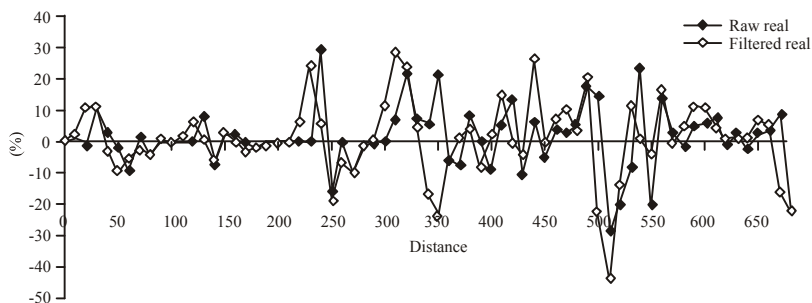
Profile 3: Illeh Road. Ekpoma

From profile 3 Illeh Road, Ekpoma intervals 0-30 m is weak and conductive and therefore unstable. While between 40-100 m is stable or competent and therefore none-conductive, between 110-610 m is fairly stable, while between 660-680m is stable (Table 3 and the profile 3 graph).
