The Construction of Church of the Taksiyarhis in Ayvalık: Structurally Problems and Intervention Techniques

Barış Özkul and Bedriye Asimgıl

Balıkesir University Engineering & Architecture Faculty, Balıkesir, Turkey

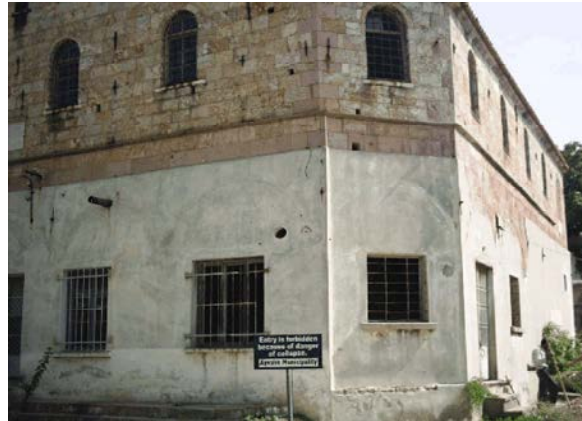
Construction System: Taksiyarhis Church shown in Figure 1 is masonry structure with stone and timber frame system, approximately 11:40 X 20.65 m. It is 3.84 m in height and a total height is 11.65 meters 2-storey building. Outer wall thicknesses is 65 to 75 cm. Wood column diameter is 42 cm, height is 4.7 meters.

Fig. 1: Masonry walls in the lower floor formed later

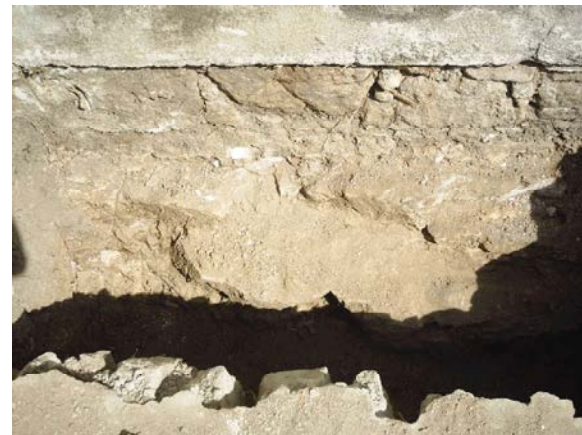
Building Foundation: As shown in Figure 2, the stone walls were examined by opening the observations pits at various points.

In the survey, the obvious damage was not observed in depth of 1.1 meters of classic stone wall footings. Considering that wear out over time of the

Fig. 2: Foundation of Stone Wall

binding mortar, it is thought that reinforced with wire mesh-reinforced plaster of stone foundation will contribute to earthquake behaviors of the top structure. As shown in Figure 3, special plaster wire mesh reinforcement is recommended for administration

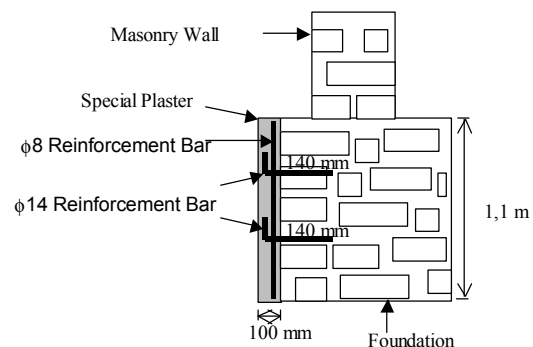
Fig. 3: Special Plaster Mesh Steel Reinforced that is proposed for building foundation implementation

- Opening up building foundation in width of 1.1m. along the perimeter of the structure

- Basically, in both directions (horizontal and vertical) with intervals of 30 cm to the holes of the anchor rod 14 epoxy embedding to a depth of at least 14 cm,
- Basic depth and an for steel reinforcement mesh, placed on the thickness of at least 100 mm, while the share of rust is recommended to be at least 30 mm of plaster. Recommended 4 volumes of special plaster sand, 1 volume and 1 volume of cement will be made with a mixture of lime.

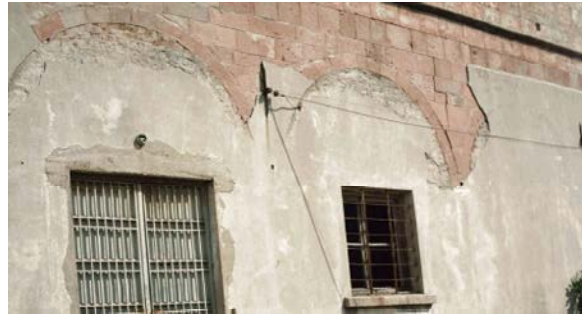
Masonry Walls: In original structure, the outer section on the vertical columns to each other masonry wall is constructed by connecting with belts. In present case, as shown in Figure 4, vertical columns and filling the spaces between the arches of the outer wall is formed as masonry wall altogether.

Fig. 4: Gaps made filling with masonry walls between Vertical Columns and Arches

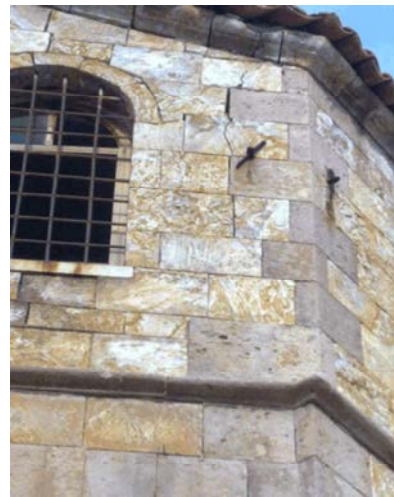
Cracks depending on the time were detected in the outer parts of stone walls. As seen Figure 5, in entrance of the building, on the top floor of the church roof, or during the repair, medium-grade a crack was detected.

Fig. 5: Cracks on masonry wall

Original slurry-like material under reduced pressure is recommended for cracks occurred in the outer parts of building. In the building entrance, the cause of the formation of cracks should be removed, before moderate cracks repair. Roof load on Cracks at the point of the junction of two perpendicular walls should be mitigated by using lower density materials such as with tile. Then, cracks must be repaired under reduced pressure with injection method. At the point of that the cracks width is 4 cm. periphery of the bearing wall elements should be expanded with rebuttal method. Texture, original stone-brick and mortar should be recreated with original manner.

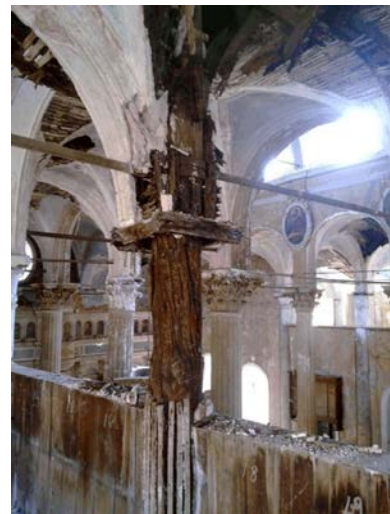
Wooden Columns: In time, infestation and yeast occurred in wooden columns and in some parts of the timber frame.

As a result of roof damage, moisture, humidity and decay have occurred. As shown in Figure 6, it is seen that this damage was seen in advanced level especially in the embellished wood column. First of all, it is proposed to be replaced with new ones if timber ornamental plasters stucco decorations suffered particularly to insect damage. In addition, local repair is recommended for wood column that is located in sub-base parts of column. This join part that will be formed by the combination of local repair should exhibit the desired behavior statically.

Fig. 6: Damaged Wood Columns

to building in historical texture [6]. For these reasons, carbon fiber is recommended to ensure continuity of wood fibers in the end region of the wood column. Thus, the pressure and the tensile strength increase.

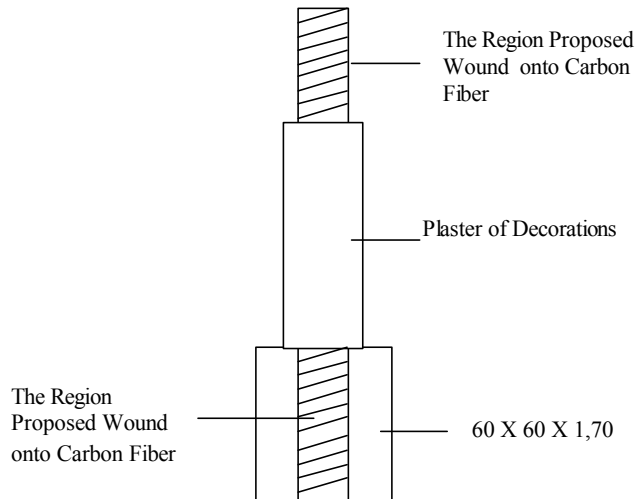
Fig. 7: Carbon Fiber Winding onto Wood Column with epoxy

During the repair, primarily, it is recommended that plaster base in the lower part of the column should be open and column end zone should be exposed. After spraying for mushrooms infestation, maintenance will be made the carbon fiber winding by epoxy method as shown in Figure 7. This method is similar to fret winding of vertical rebar of circular sectioned reinforced concrete columns. The burr-like particles will be cleared with surface cleaning powder in the section that carbon fiber will apply. The surface must be dry that application will be made to this surface. The epoxy resin should be saturated with brush after the preparation area that application will be made. Preformed carbon wood fiber is wound onto the column as shown in Figure 7. Epoxy resin will be applied again. The surface will be roughened before epoxy resin drying and will be ready for plaster restitution. In the central area of the column, the region that is completely

covered with plaster is protected. Carbon fiber continuity will be ensured with repair between column ends and central region.

Carbon fiber in the end region of the column with the suggested repair, in the junction point of wooden columns and iron tie, the damage (corrosion and rot) will be prevented.

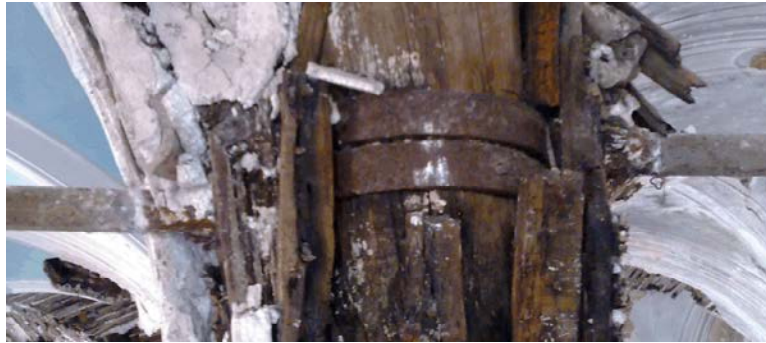
Iron Braces: The iron braces in inner part of building among wooden columns, as shown in Figure 8, were exposed to corrosion due to moisture and humidity. The stained with a dye doped of iron braces is recommended after surface cleaning.

Fig. 8: Corroded Iron Braces

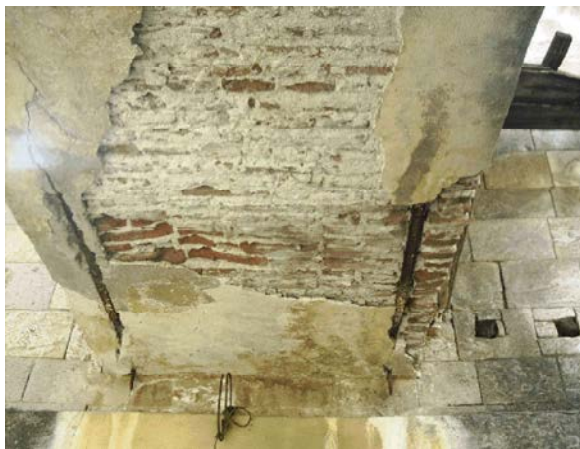
External Stairs: The wrought iron reinforcement, as shown in Figure 9, is exposed to severe corrosion in the external environment in the bottom of the stairs that was built as an arch. It is recommend that this arch-shaped staircase should be suspended and iron fittings replaced with wrought irons based on the same properties of wrought.

Fig. 9: Iron Reinforcement Heavy Corroded

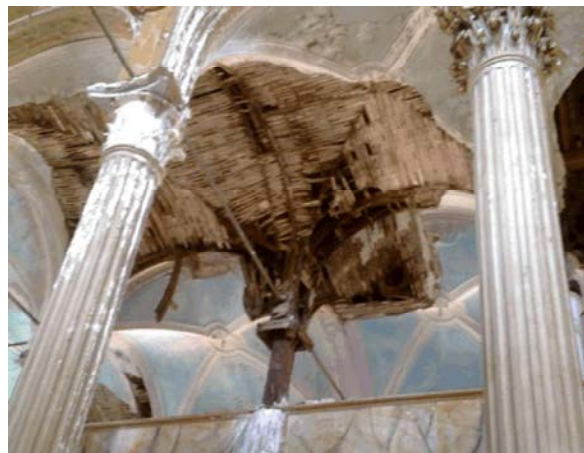
Fig. 11: Status of the damaged roof

However, the roof is unavailable before the restoration. (Figure 11). Removals of all roof tiles unoriginal, removal of renovated wood are necessary. In repair of removal parts, the wood in accordance with the original should be selected. Taking the necessary drainage precautions, roof tiles should be changed which

is lighter than the current roof tile. In building elements not being able to be replaced, such as vaults, etc, carbon fiber is recommended that was recommended for the repair of wooden columns.

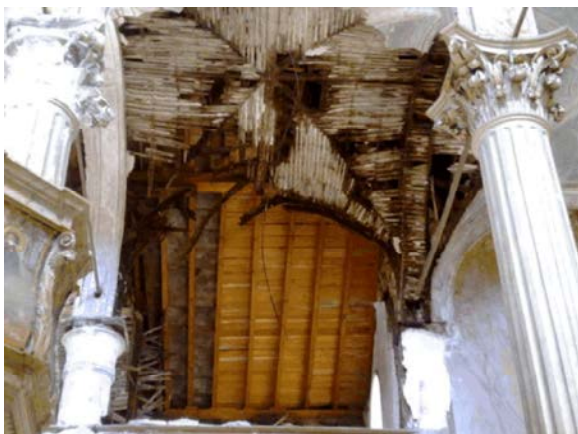
Roof: As shown in Figure 10, the damage on the roof structure has occurred. Over time, a portion of the roof was reconstructed, by ignoring the principles of restoration. Thus, the much more serious damage was prevented.

Fig. 10: Roof repair by ignoring restoration principles

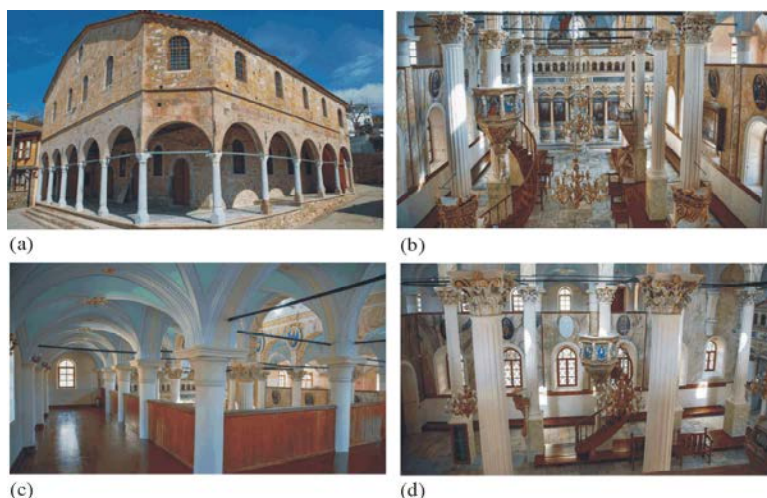
Fig. 12: Completed Restoration of Taksiyarhis Church
