Material Characterization, Structural Analysis and Strengthening Proposals for İnebey Madrasa in Bursa, Turkey

Abstract: The researcher of this paper want to analyse the current state of the madrasa by using Non Destructive Test Methods (NDT). Mechanical and physical tests are done *in-situ* and in laboratory for the characterization of the materials used in the Madrasa. Material properties are calculated for the composite materials. The composite materials properties are adopted to the curent in situ model under the death and earthquake loads and current state of the madrasa is analysed. According to the results of the analysis the proposals for restoration of the madrasa are given.

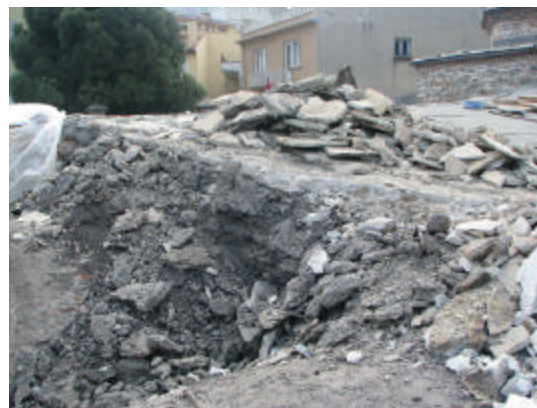
Fig. 8: Different materials filling between and above the vaults

The roof of the madrasa had several interventions by filling materials between and above the vaults (Fig. 8 & 9). The filling materials are applied by separate layers which were consist of different materials such as clinker, limestone, brick pieces, concrete and reinforced concrete. This load was calculated 700 ton for 400m² after taking off the filling material on and above the vaults. It is seen that the roof of the madrasa had loaded anormously which reaches to 1.75ton/m².

material for filling caused a very big problem in the structure. All the cracks were occurred after the loading on the roof. For decreasing the tensile stresses all cracks can be filled with the adequate injection material and the maximum tensile stress areas that caused big cracks can be covered with the FRP (fibre reinforced polymer) materials for strengtening the structure. Also existing tie bars which were exposed to the corrosion can be cleaned and strengthened, timber beam gaps can be fulfilled by the new timber beams during the restoration works, with the respect to the safety of the structure.

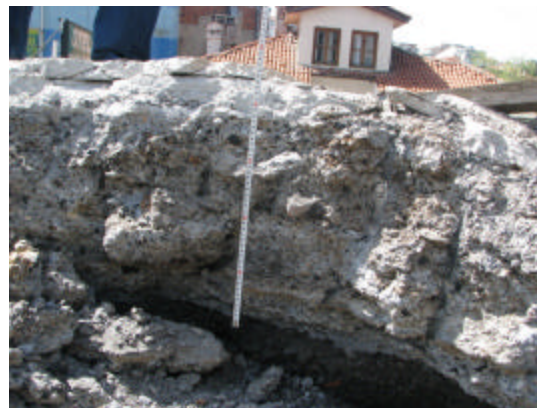
Fig. 9: Layers of filling materials on vaults

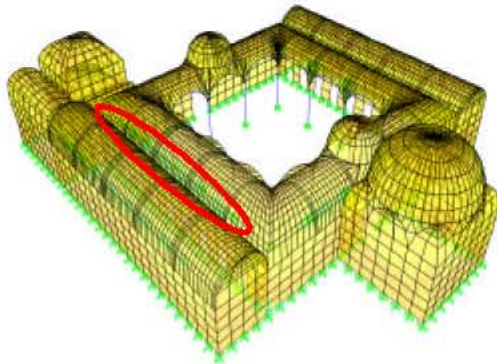
Fig. 11: Tensile stresses on the edge of the vaults

The filling load on the vaults cause tensile stresses on the edge of the vaults maximum 0.3-0.4 N/mm² but not exceeded the limit tensile stresses of 0.499 N/mm² as shown in Fig. 11 under dead loads. *In-situ* cracks seen irregularly on this area.

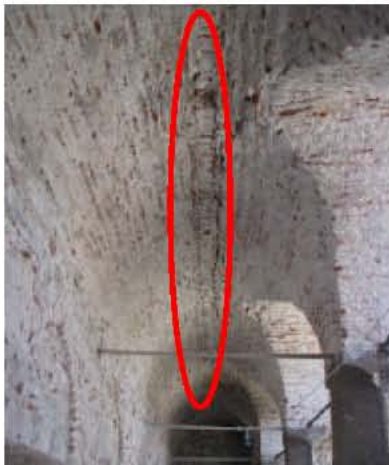
Fig. 12: *In-situ* cracks under vaults in North-South direction

Under the vaults it was seen in the analyse program that the maximum tensile stresses has reached 0.43 N/mm² which was close to the 0.495 N/mm² limit tensile stress value. *In-situ* there were main and regular cracks observed on this area which were same results in the analysis program. Figure 12 & 13 shows the North-south direction, Figure 14 & 15 shows the east-west directions.

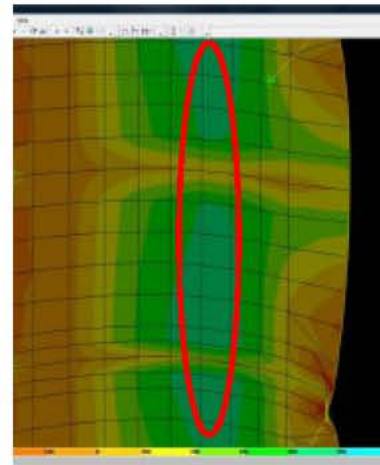
Fig. 13: Maksimum tensile stresses under vaults in North-South direction

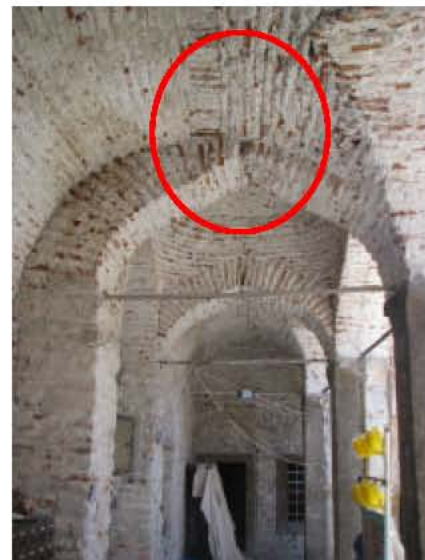
Fig. 14: *In-situ* cracks under vaults in North-South direction

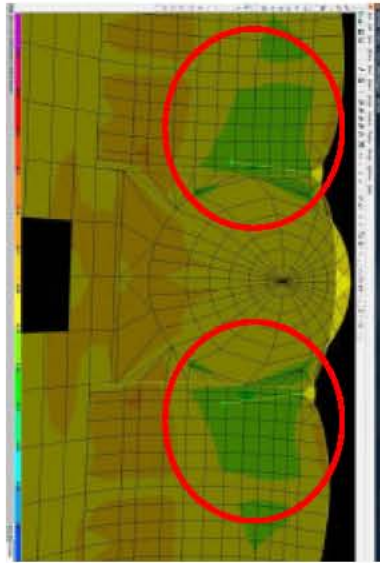
Fig. 15: Maksimum tensile stresses under vaults in North-South direction

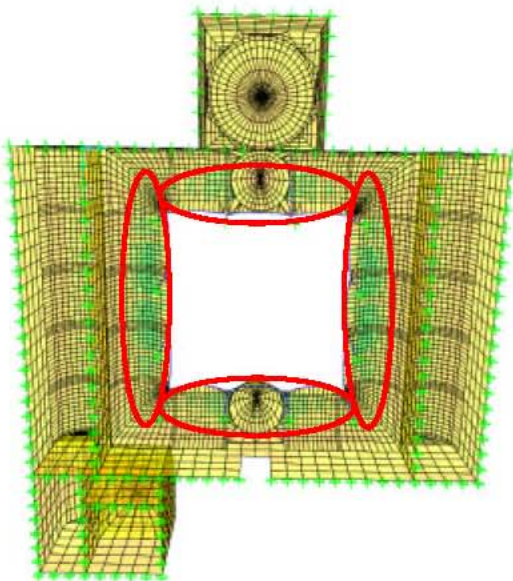
Fig. 16: Maximum tensile stress areas under dead loads

Figure 16 shows the maximum tensile stress areas under dead loads. *In-situ* cracks are continuously occurred under the vaults close to the static analyses.
