Geotechnical Assessment for Gully Erosion Control and Management in Agulu-Nanka, Southeastern Nigeria

Abstract: This study is aimed at providing geotechnical parameters and data of the soils, identify problems and features making the area susceptible to gully erosion and proffering sustainable solutions to problems of gully erosion in the affected areas of AguluNanka, Anambra State, Southeastern Nigeria. Standard methods were used in the geotechnical assessment. The result of the study revealed the following: topography of the land shows a high sloppiness which makes it highly susceptible to erosion, predominantly that of weak clay and loose sandy clays, natural moisture content ranges from 1.71% –12.53% - this is because the soil have low retentive capacity, hence cannot hold much water. Compaction test shows the maximum dry density (MMD) and the optimum moisture content (OMC) of the soil to be very low; plasticity index ranges from 0–33.283; compacted bulk density between 1.55- 1.76 kg/m³; the specific gravity ranges 1.68 – 2.06, with permeability ranging between 1.32×10^{-3} and 1.63×10^{-3} cm/sec. This indicates that the area is highly prone to gully erosion which has proven

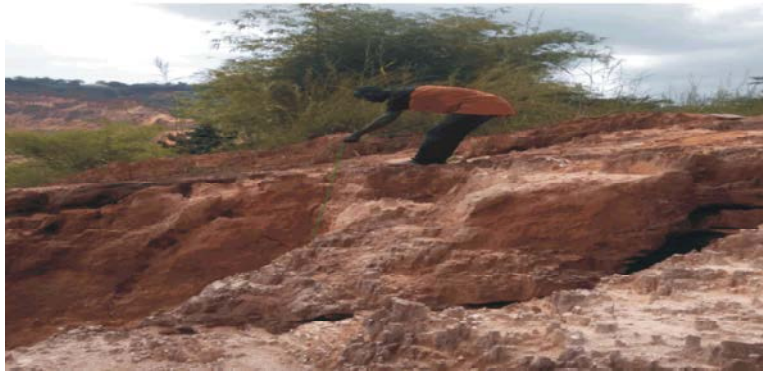
Fig. 9: Measuring of Gully Size

- Gully Width = Range is between 0.13m-397.20m
- Gully length = Range is between 10m- 4, 369.20m
- Gully Height = Range is between 2m-52.96 m
- No. of gullies sited = 12 gullies (some were concentrated)

Unfortunately, the majority of gullies in Nanka are very large, the widths ranged between 0.13m-397.20m, the gully height ranged between 2m-52.96m , while the lengths ranged between 10m- 4, 369.20mand this has contributed to loss of large expanse of useful lands which has become unsuitable for settlement and cultivation in Nanka and other parts of Southeastern Nigeria. There have been numerous attempts to curb gully erosion in these regions; especially through large-scale engineering projects, however, little has been discussed about the real causes of this menace (geotechnical and geologically) and ways to prevent their onset or the use of community-based low technology approaches to mitigate their development. The features responsible for gully erosion in Nankadepend on several factors like: high amount of land exposed, the high sloppiness of the land, the nature of the soil, poor method of land management, the intensity and duration of rainfall [18, 19, 20, 21]. The findings of the study is also in line with the findings of Hudson [22], who stressed that soil erosion has damaging effects on land and agricultural production. Akpata and Atanu [23]; Salako *et al.* [24] also added that the increasingly deforestation which affects environmental conditions results from low level of education among the people in the area, this generally causes human activities contributing to soil erosion.
