Cleaning and Consolidation of Damaged Plasters, Writings and Drawings on the Walls of the Pilgrims' Room in the Monastery Anba Hadra Aswan, Egypt

Mona M.E. Khalil

Department of Conservation, Faculty of Archaeology, Aswan University, Aswan, Egypt

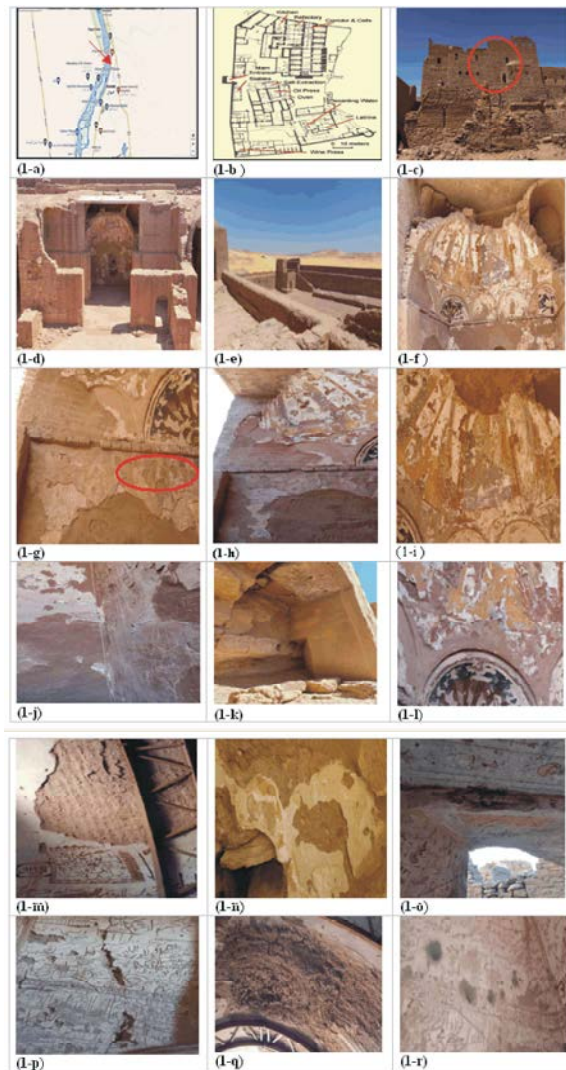
Fig. 1: (from a to r): Location and status of the Anba Hydra monastery. a: Map showing the location of the monastery of Anba Hydra. www.google.com/maps/. b: shows the plan of the monastery. c: shows the construction of the Anba Hydra monastery on two levels. d : An overhead view of the church Ruins of a church on the lower level, with plaster and painting details. e: shows the desert surrounding the monastery. f: shows the vaulted arch and salts on the surface of the bricks in Al-Haniyah. Photograph taken in 2019. g : shows the remains of a painting of haloed figures seated and shows the loss of mortar. Photograph taken in 2019. h : showing the effect of wind on the main structure. Photograph taken in 2020. i: shows the color peeling, falling layers of plaster and the final disappearance of drawings from the vaulted arch and walls of the monastery. Photograph taken in 2019. j: shows the separation of the surface layer from the support. and damage from the Hajj's room k: shows the deep cracks caused by the loads at the inlet of the fryer. l: depicts a detail of the semidome and the separation of the colour crust due to temperature differences. Photograph taken in 2020. m: shows a fall in the plaster layers, which are to be completed from the inner walls of the room. We also see rust on the walls. n: Falling of plaster and cracks in building materials. o: Ceiling of cave at the west end. It served as an ancient Egyptian rock tomb that was used by monks. Paintings are dated to 600 or 700 AD. p: Murals and paintings in arched rooms beside the northeastern corner display the cracks resulting from the loads in the Anba p : Murals and paintings in arched rooms beside the northeastern corner display the cracks resulting from the loads in the Anba. q: shows the previous restoration on the walls while preserving the integrity of the wall below the beehive and not scratching the surface. r: Illustration of the concentration of fossilised hives on the walls.

of hard veins and pebbles. However, Christian builders in Nubia often used monolithic columns of sandstone or gneiss that came from nearby quarries. In the southern part of the Nuba Valley, silt from neighboring regions is the most accessible and abundant material [10]. Figure 1 (from a to r).

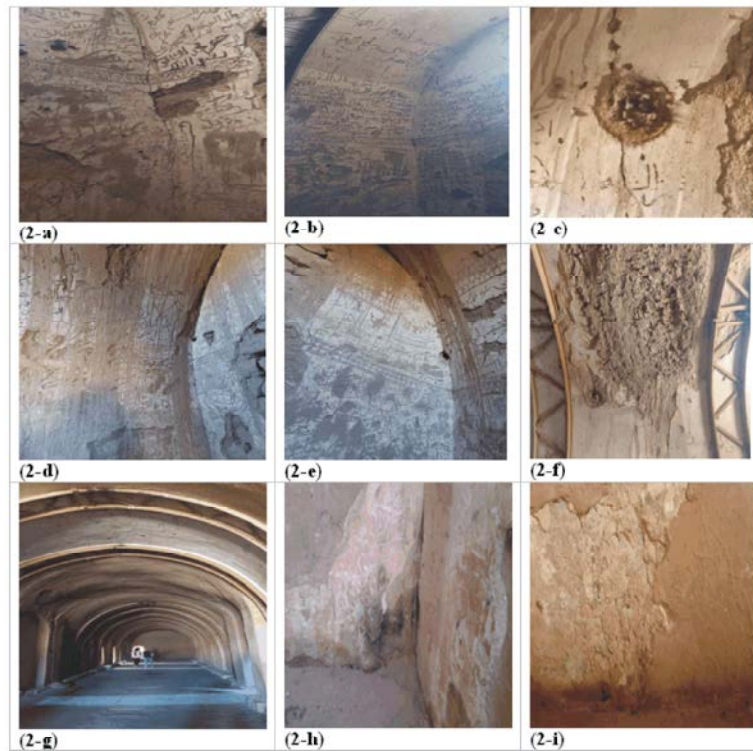
Fig. 2: (from a to I): The status of Pilgrims' Room in the Monastery. a: Murals and paintings in arched rooms along the northeastern corner layers of dirt and dust. Photograph taken in 2019. b: shows a large fragmentation and collapse in the plaster and the writings that are important for the dating of historical events. c: The hives of wild bees are dotted abundantly on the walls. Photograph taken in 2020. d: shows significant fragmentation and collapse in the plaster layers. Photograph taken in 2020. e: shows the inscriptions and writings that will be placed on the entrance walls. Photograph taken in 2019. f: shows the metal supports installed on the walls. With these existing supports, we need to treat the rusty iron left on the walls. g: The corridor goes north-south and contains the monks' rooms. Photograph taken in 2020. h: shows soot spots on the surface and a blood spot from bats. Photograph taken in 2020. i: shows the salts on the surface of the preparation layer, fungal growth in many areas and biological residues.

One of the main problems that we face in order to be able to preserve the fragments of the plaster layers is that we find exposure, cracking and cracks in the remains of the walls of the building on which the plaster, drawings and historical writings are important to us. Among the external factors that have a significant impact on damage (rain, humidity, wind, sun and heat). And the presence of decomposition and damage between the plaster layers and the walls appears to us in the form of a powder between the layers with the passage of time due to the destructive effect of water (liquid and/or steam) [14] and if the needed measures are not taken, this finally leads to great destruction and damage that cannot be restored and the final loss of this The important archaeological heritage of these types of writings and drawings on the plaster walls inside the room that was designated for Muslim pilgrims. Fig. 2 (from a to i).

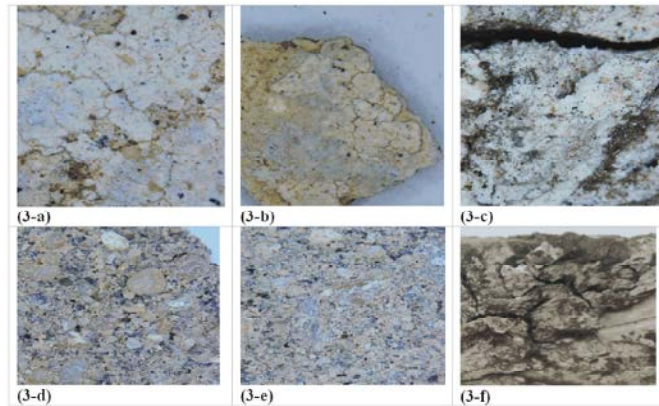
Fig. 3: (from a to f): Portable USB microscope results. a: Wall cracks and separation of plaster. X400. b: shows a high hygroscopic property that crystallizes and re-crystallizes the salts. X500. c: Cracks and holes because of internal pressures. d: shows Background sample compounds are shown for residual rock and sand. X600. e: The background of the sample shows the carrier compounds of the sand grains. X600. f: shows the precise surface details: a large amount of sand in micro cracks, mud and dirt

The use of a USB portable microscope for investigation is a simple and advanced technique, which can magnify objects up to 1000 times their original size [21]. Figure 3 show the surface details of these building materials, which have a great quantity of sand combined

with red and brown colors. There are many cracks. Investigation of the types of dirt and damage in the plaster. Figure 3 (from a to f).

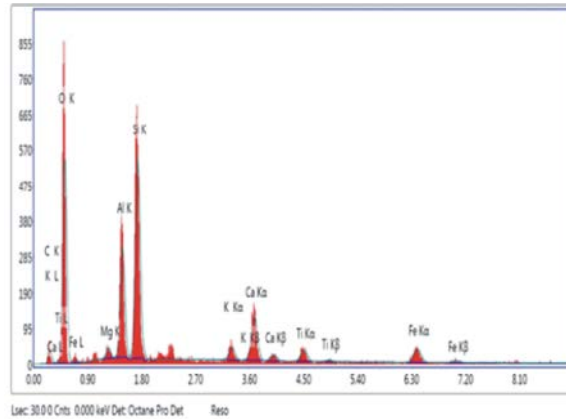
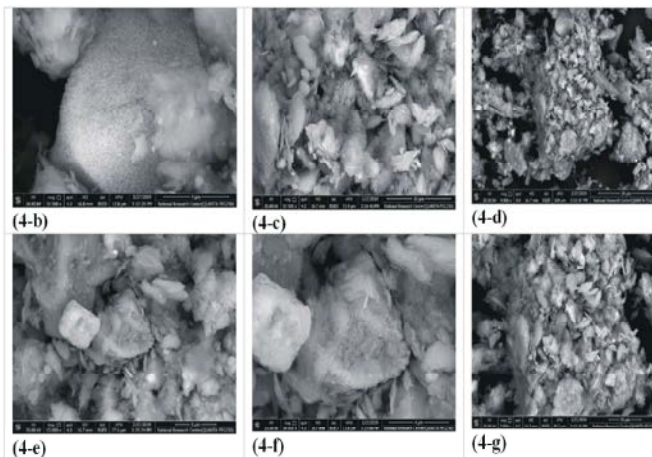
(4-a)

Fig. 4: (from a to g): SEM – edx microscope results. a: shows SEM of the damaged sample from plaster wall. b: shows collapse of the plaster. X3000. c: shows some weathered surfaces, internal cracks and the presence of salt crystals. X1300. d: shows weathered surfaces and increase of dirt. X4000. e: shows the presence of salt crystals. X1500. f: shows Damage and collapse of the plaster layer. X3000. g: shows Obvious deterioration and increase of dirt. X7000

Analytical Techniques: Scanning electron microscopy with an EDS microanalysis detector (SEM). The results at Figure 4 (from a to i) showed that the preparation layer consists of: quartz grains of different sizes, most of which are semicircular; a heterogeneous and coarse texture; calcium carbonate, as the binding is calcium carbonate and a small percentage of iron oxides. Potassium carbonate salts, calcium sulphate salts, halite salt, sodium chloride and calcium carbonate were discovered. Salts formed on the preparation layer, potassium feldspar (Kalsi3O8) and a small percentage of gypsum. Figure 4 shows the SEM of the presence and percentages of Ca, C and O for calcium carbonate, while the small peaks of Si, Fe and Al. as The USB digital microscopy investigation revealed some degradation in the samples, such as minor cracks and cracking of mud plaster caused by physical and weathering factors. The results of the SEM examination presented the morphology of the surface of the studied samples, which seem to be weathered. Figure 4 (from a to g).

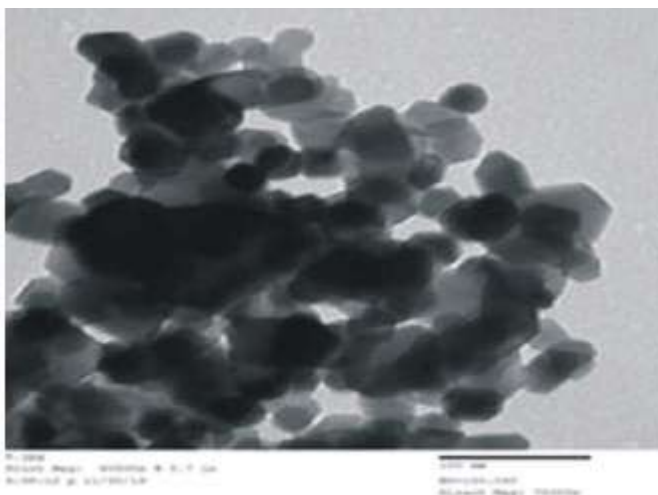
Fig. 5: Shows the TEM images of CoFe₂O₄ nanoparticles. according to Control Department Material Data Sheet

Size & Shape: TEM were done on JEOL JEM-2100 high resolution transmission electron microscope at an accelerating voltage of 200 kV, respectively. Figure 5 shows the TEM images of CoFe₂O₄ nanoparticles and Figure 6 shows the XRD pattern of the prepared

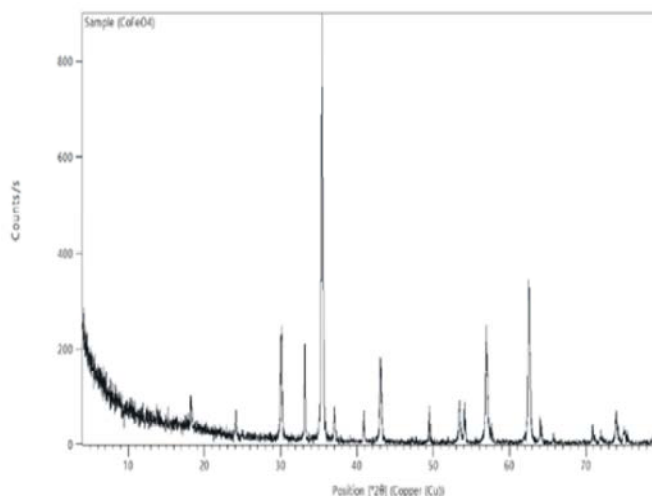
Fig. 6: Shows the XRD pattern of the prepared nanoparticles

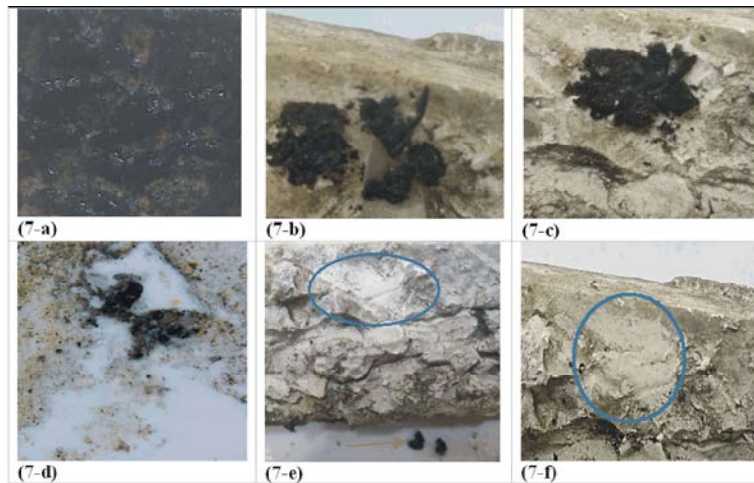
Fig. 7: (from a to f): Nano gel results. a: shows the use of Nano gel for the purpose of cleaning the surface. The Nano gel with magnetic nanoparticles has a black color. b: shows that the Nano gel, after being left for a while, has dried on the surface of the gypsum. c: shows that the Nano-gel, after being left for a while, has been separated from the surface of the gypsum. d: Shows the gelatinous appearance on the gypsum surface. e: The part becomes clear after the cleaning process and the gel falls off easily from the surface. f: showing after cleaning.

nanoparticles. Table (2) contains the properties. Experimentally, we find that the use of Nano-gel in cleaning and removing unwanted dust from surfaces showed success and efficiency in removing dirt as shown in Figures 7 (from a to f).

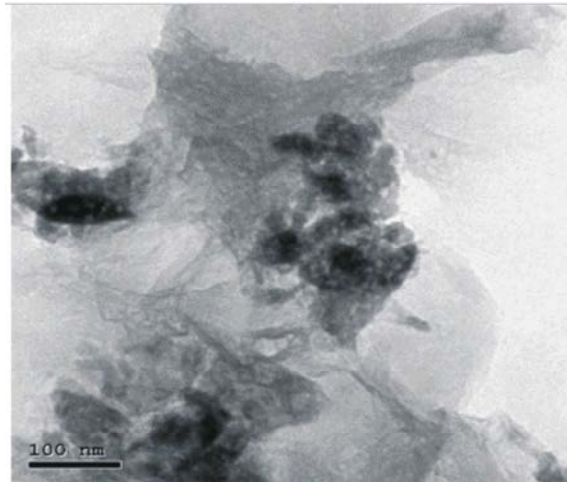
Fig. 8: Shows the TEM images of prepared Graphene oxide

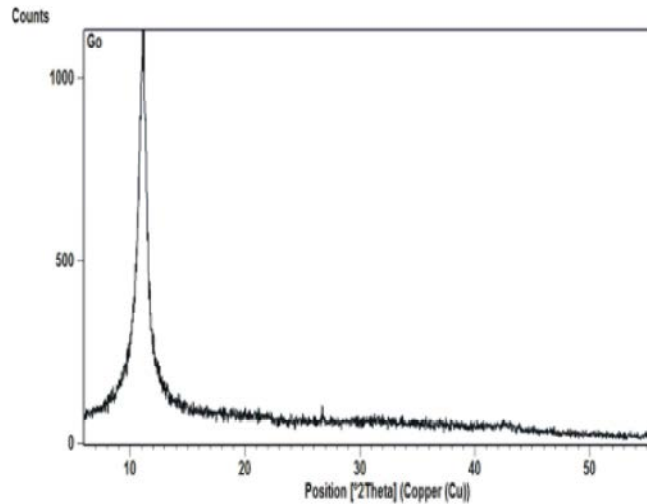
Fig. 9: Shows the XRD pattern of Graphene oxide
