## Impacts of Landfill on Groundwater Quality in Eligbolo-Elioizu, Obio/Akpor Local Government Area, Rivers State, Nigeria

**Abstract:** This study aims at assessing the impact of landfill on groundwater quality in Eligbolo-Elioizu, Port Harcourt, Nigeria. The lateral and vertical flow of waste contamination on soil and groundwater quality was examined using Wenner Array 2-D resistivity imaging. Two high dominants of leachate and gas zones were identified on profile one of 2-D resistivity imaging, two groundwater flow directions was identified, flowing downward to the southern direction of the state, from the West and East parts of the dumpsite. Leachate and gas infiltrate into the subsurface at the depth ranging from 4.91m to 14.9m. Waste gasses such as carbondioxide and ammonia were dominant in the landfill, stunting the growth of toxic substances. The concentration of leachate percolates down from the dumpsite with time and it is dominant on the soil surface than groundwater. The 2-D resistivity image result of all the profiles indicated that groundwater and soil in the vicinity of the landfill have been contaminated by leachate and waste gases (probably CO<sub>2</sub>, CH<sub>

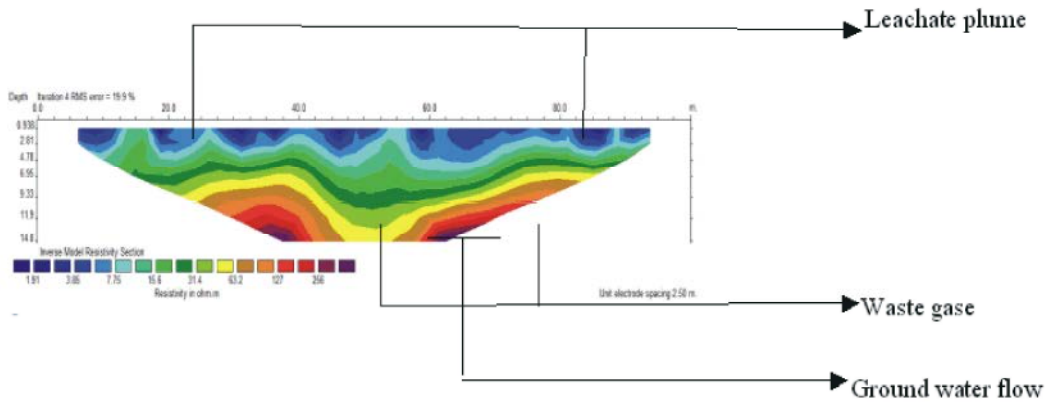
Fig. 6c: Inverse model Resistivity section along profile 3

**Profile 3:** These profile lies 20m away from the edge of the waste dump at North/East between minor and street road. The two dominants low and high anomalous zones were delineated (Fig. 6c). The low resistivity anomaly (Dark to Light Blue) was mapped on the surface of the section stretching throughout the entire length of the traverse. With resistivity varying  $\geq 1.91\Omega m$  to  $7.75\Omega m$ , isolated from 0.0m to 12.5m and continued from 17.5m to 95m, at depths varying between 0.930m to 4.76m are interpreted as sand or soil saturated with leachate plume contaminants that contains dangerous pathogens, including dissolved organic and inorganic constituents. The layer of high resistivity (Green-yellow) with resistivities ranging from  $15.6\Omega m$  to  $63.2\Omega m$  at the depth of 2.81m to 6.95m, sandwiched downward at the centre of the surface points between 40.0m to 57.5m, with the depth ranging from 6.95m to 14.8m is identified as porous and permeable sandy layers of varying grain sizes and moisture contents. The zones colours (Red-Purple) of anomalously high resistivities between  $127\Omega m$  to  $\geq 256\Omega m$

at the depths of 9.38m to 14.8m is identified as waste dump gases (Methane, Ammonia, carbon (IV) oxides or Sulphur (IV) oxides) which could be due to Anaerobic decomposition of the waste dump.

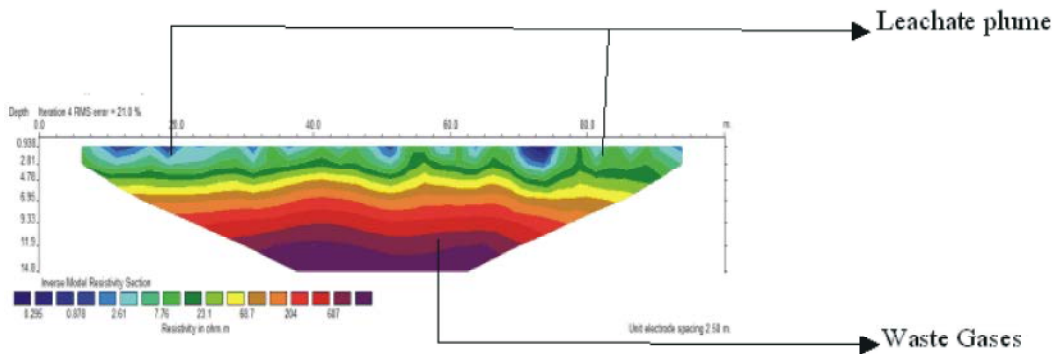
Fig. 6d: Inverse model Resistivity section along profile 4

**Profile 4:** The profile lies 20m away from the edge of the waste dump at North/East along gas turbine right of way. The two dominant slow and high anomalous zones were delineated (Fig. 6d). The low resistivity zone colours (Dark-light Blue) ranges from 0.295 $\Omega$ m to 2.61 $\Omega$ m is isolated at the top section of the profile ranging from 7.5m to 39.5, 52.5m, 85m to 87.5m and 90m to 95m, at the depths of 0.938m to 2.81m are identified as leachate plume. The (light green to yellow) colour with resistivities ranging from 7.76 $\Omega$ m to 68.7 $\Omega$ m at the depths of 0.938m to 4.76m with surface points ranging from 40m to 60m to 65m, 77.5m to 80m, 82.5m to 85m, 87.5m to 90m is identified as porous and permeable sandy layers of varying grain sizes and moisture contents. While the zones colours (Red-Purple) of anomalously high resistivities between 204 $\Omega$ m to 607 $\Omega$ m with the depths of 6.96m to 14.8m is identified as waste gases (Methane, Ammonia, carbon (IV) oxides or Sulphur (IV) oxides) which could be due to Anaerobic decomposition of the waste dump.

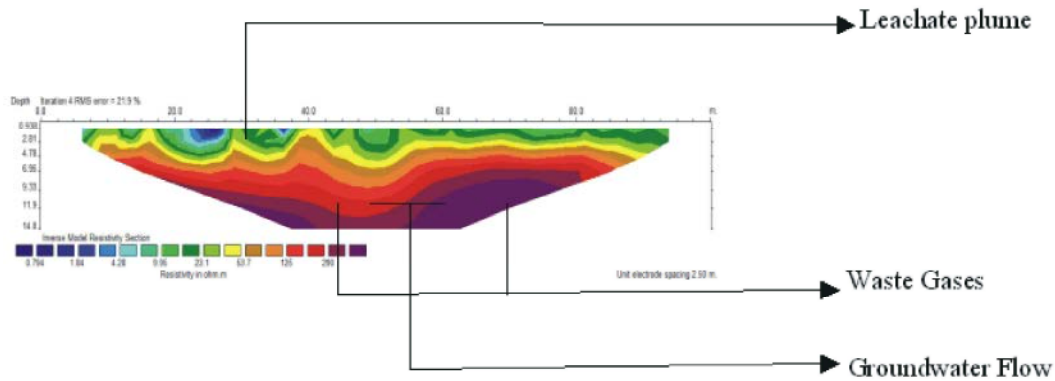
Fig. 6e: Inverse model Resistivity section along profile 5

**Profile 5:** These profile lies 15m away from the edge of the waste dump at the South/West direction of the landfill, along the turbine line and dumpsite entrance. The two dominant slow and high anomalous zones were delineated (Fig. 6e). The low resistivity zone colours (Dark-light Blue) ranges from 125 $\Omega$ m to 290 $\Omega$ m with surface points of 20m to 27.5m and 35m to 37.5m at the depths of 0.938m to 2.81m is identified as leachate plume. The (light green to yellow) colour with resistivities ranging from 9.95 $\Omega$ m to 53.7 $\Omega$ m at the depths of 0.938m to 4.76m is identified as porous and permeable sandy layers of varying grain sizes and moisture contents. While the zones colours (Red-Purple) of anomalously high resistivities between 125 $\Omega$ m to 290 $\Omega$ m at the depths of 4.76m down to 14.8m is identified as waste gases (Methane, Ammonia, carbon (IV) oxides or Sulphur (IV) oxides) which could be due to Anaerobic decomposition of the waste dump.
